THE  
ECCLESIASTICAL  
ARCHITECTURE  
OF SCOTLAND

FROM THE EARLIEST CHRISTIAN TIMES TO THE  
SEVENTEENTH CENTURY

BY  
DAVID MACGIBBON AND THOMAS ROSS  
AUTHORS OF "THE CASTELLATED AND DOMESTIC ARCHITECTURE OF SCOTLAND"

VOLUME ONE

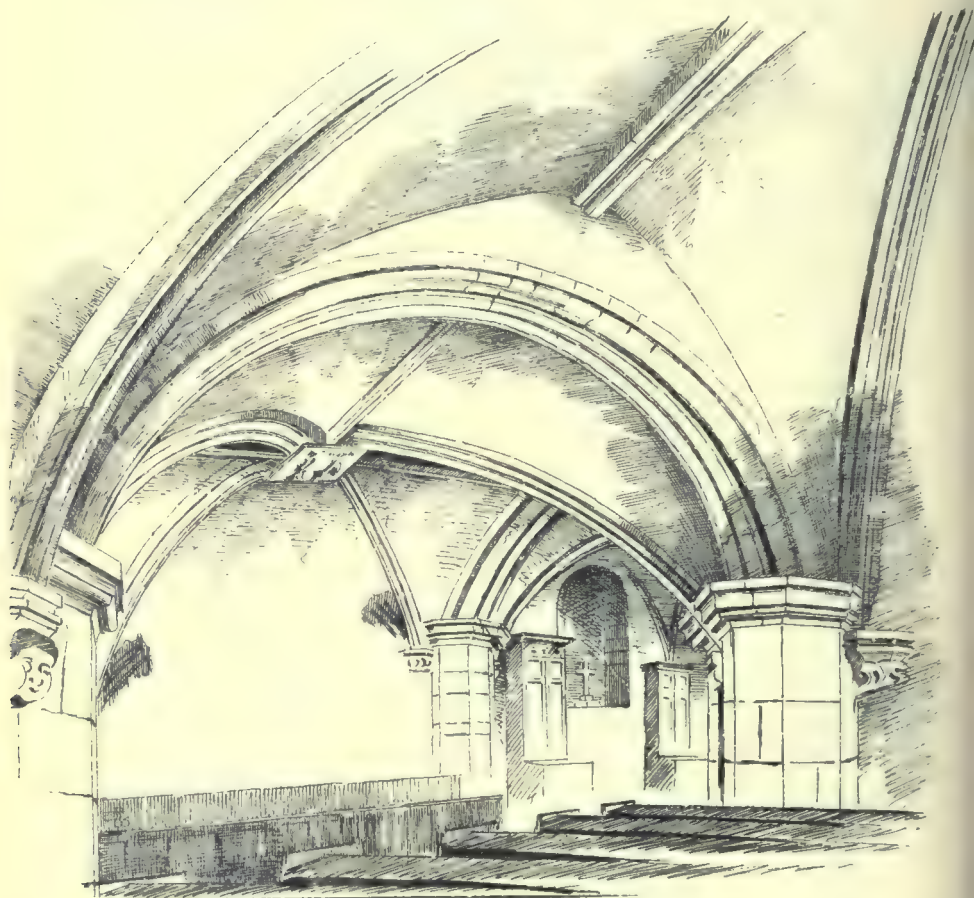
FIG. 393.—St. Nicholas' Church. Crypt, looking North-West.

round arch (Fig. 393), and is a prominent example of the love of the Scottish builders for this form of arch all through the Gothic period. This is the only place in the crypt where the width is sufficient to allow

of such an arch reaching the roof without the necessity of undue gabling above the arch, and it further has the effect of giving a dignity and effect of separation to the apse which it would not have possessed with a pointed arch. Each compartment of the apse has a central boss, two of these are shown (Fig. 394). All the intermediate ribs spring from corbels at a lower level than the caps of the responds (Fig. 395), from which the separating arches spring, and the long diagonals of the centre compartment cut

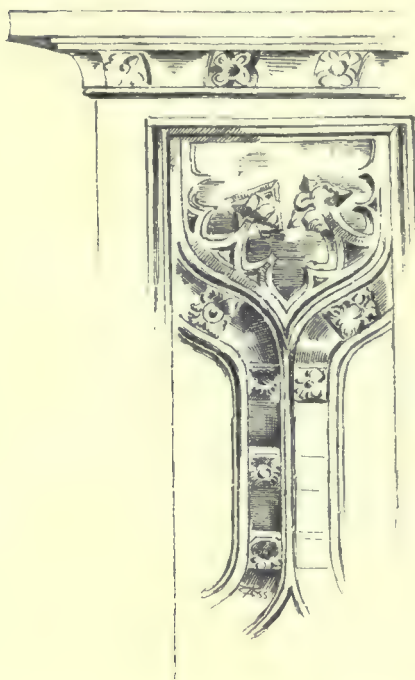
FIG. 396.—St. Nicholas' Church. Carved Bench End.

There is a considerable amount of carved woodwork—bench ends and backs of seats—in the crypt, some of the fifteenth or sixteenth century (Fig. 396), and some of a later period. These are probably part of the work done by John Ferdour, "wricht," who, in 1507, contracted to make twenty-four stalls and other furniture "substanciusly and honourable as he may," as they are begun, "and bettir gif he can" (p. 77).

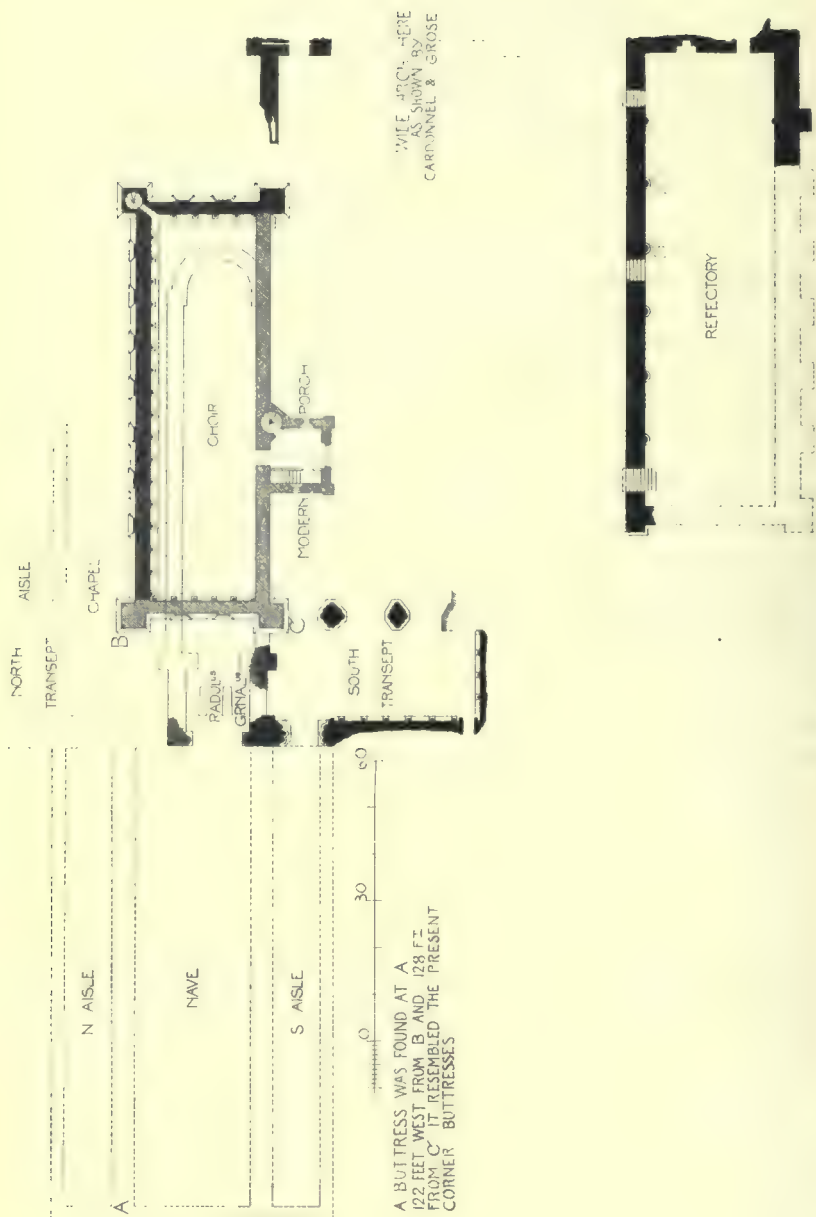
FIG. 897.—Coldingham Priory. Plan.

The foundations of an early church with an eastern apse were found in excavations made in 1854. The outlines of this early church, as shown on a plan prepared by Mr. Hunter, in 1858, for his history of the priory, are drawn in outline on Fig. 397. These were, doubtless, the remains of the church erected in 1089. It had the circular apse of the early Norman churches.

Lying at a distance of 76 feet south from the church, and at a somewhat lower level, are the walls of a great hall (see Fig. 397). The wall, which runs east and west, is fully 100 feet in length, and has attached to it pilasters of segmental form, measuring 1 foot 10 inches across, at

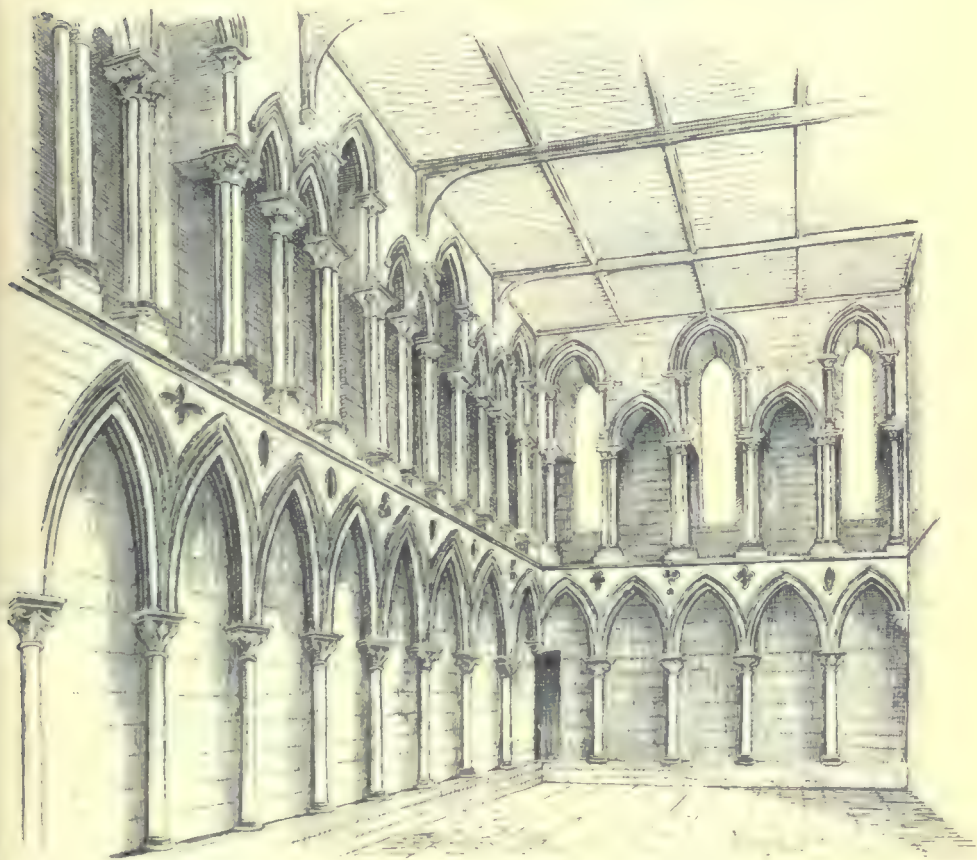
FIG. 399.—Coldingham Priory North and East Sides of Interior.

The design of the interior of the north and east walls (Fig. 399) is very beautiful. It is carried out, like the exterior, in two stories. The lower story consists of a continuous pointed arcade, placed close to the wall, with single detached shafts and bold first pointed arch mouldings. The bases of the shafts rest on a stone bench 1 foot 6 inches high, and the caps are varied with rich transition and first pointed carving (Fig. 400). Curious trefoil and vesica openings are inserted in the spandrels. (Fig. 403.)

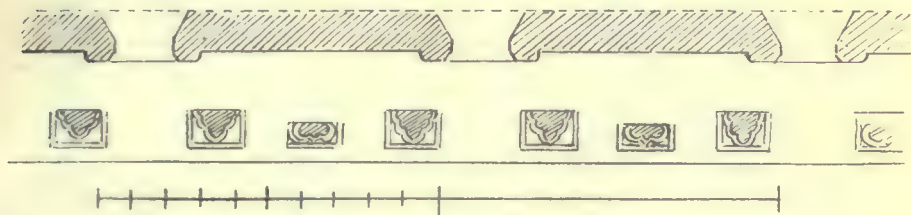
FIG. 401.—Coldingham Priory. Plan of Upper Gallery.

The upper story consists of a detached arcade, having a passage behind it in the thickness of the wall (Fig. 401). The arcade comprises an alternation of high and low pointed arches, two of the latter occurring between every two of the former. The shafts are alternately cinquefoil and double in section, as shown in the geometrical drawing (Fig. 402). All these details are prominently first pointed in style, the caps being elaborately carved with foliage of that period, and the mouldings being bold and distinct (Fig. 403). The little bits of foliage introduced at the points of the arches and ends of the labels and strings are also characteristic of early first pointed work.

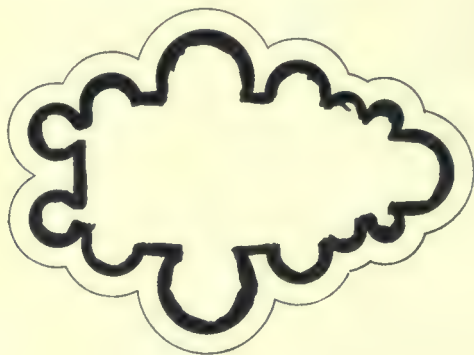
FIG. 404.—Pier in South Transept.

plan some indications of such a structure are shown. At the north-west angle of the south transept there is an arch, which has been rebuilt, being partly made up of old fragments, but the lower part seems to be ancient. The lower portions of two piers on the east side of the transept still survive (Fig. 404), and exhibit good mouldings. These seem to have formed the piers between the transept and an eastern aisle. When

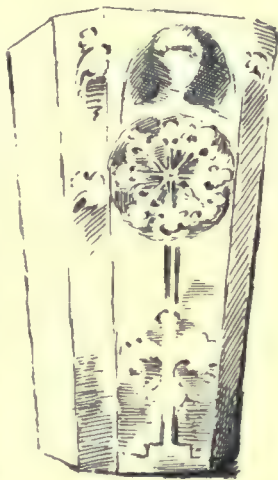
FIG. 405.

There are several grave-slabs at Coldingham, of which four are illustrated. Three of these are small in size, and the fourth is considerably larger. That shown in Fig. 405 has bevelled edges, with a foliated cross containing thirteenth century carving. At the top of the cross there is

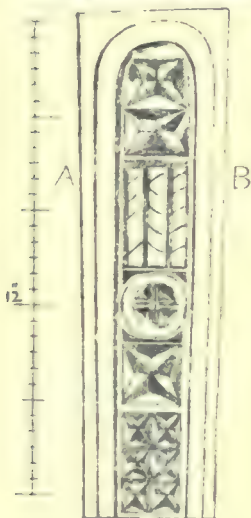
FIG. 406.

Figs. 406 and 407 are, like Fig. 405, of small size, the first measuring 32 inches high by  $10\frac{3}{8}$  inches at the top of the slab, and tapering to  $8\frac{1}{8}$  inches at the base, and the latter 27 inches high by 10 inches without taper.

Fig. 406 is of an elaborate and peculiar design. On the flat slab a shallow bead with a circular head encloses the design. This consists of two stars at the top, and then of three upright flat-beaded figures about 6 inches high, with corded lines across them; then a Greek cross, a star, and, finally, a double row of three stars. The arrangement of the stars somewhat resembles the similar features at the chancel arch of Legerwood, Berwickshire. The small slab (Fig. 407), which may be

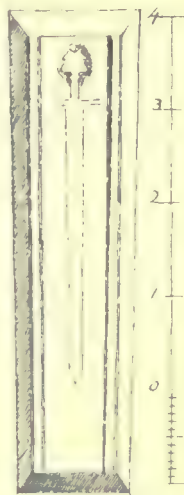
FIG. 408.

Fig. 408 is 5 feet 2 inches by  $16\frac{1}{2}$  inches at the head, tapering to 14 inches at the base, and has bevelled edges, with a flat bead at the sides only. It bears the incised outline of a sword, with a large carved knob for the pommel.

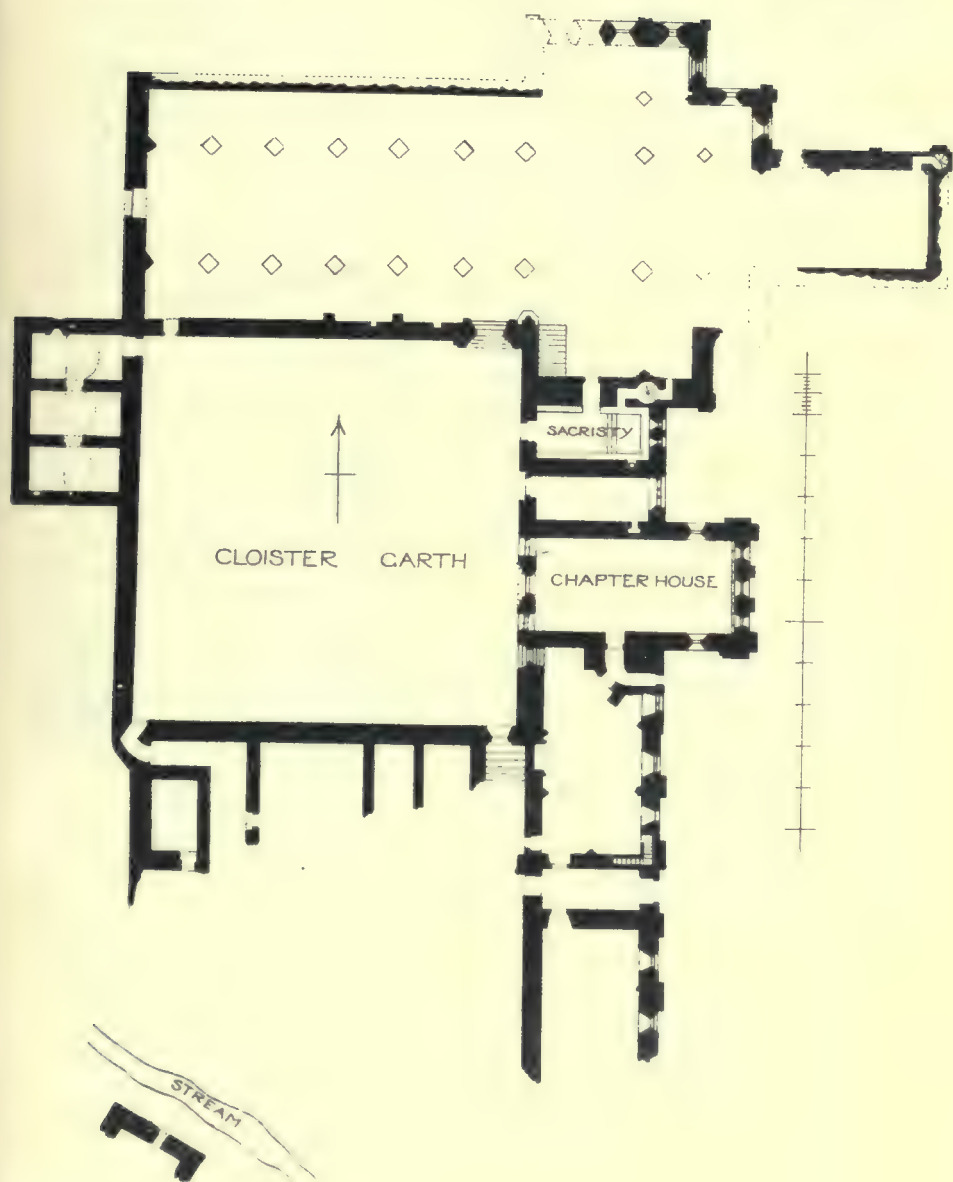
FIG. 410.—Dryburgh Abbey. Plan.

The monastery (Fig. 410) has consisted of the usual buildings surrounding the cloister, having the church on the north side, standing about ten steps above the level of the cloister garth. The sacristy, chapter house, frater, and other apartments stretch from the transept southwards along the east side; and above these, on the upper floor, were the dormitories, entering by an open staircase from the south transept, in a similar manner to the dormitories at Pluscardine, Melrose, &c. Along the south side of the cloisters lay the refectory, which, owing to the slope of the ground, was raised on a basement floor of vaulted cellars. On the west side of the cloister garth there are now only a few vaulted cellars. A small stream runs along on the south-west side of the monastic buildings, and beyond the stream are the remains of what seems to have been a detached chapel.

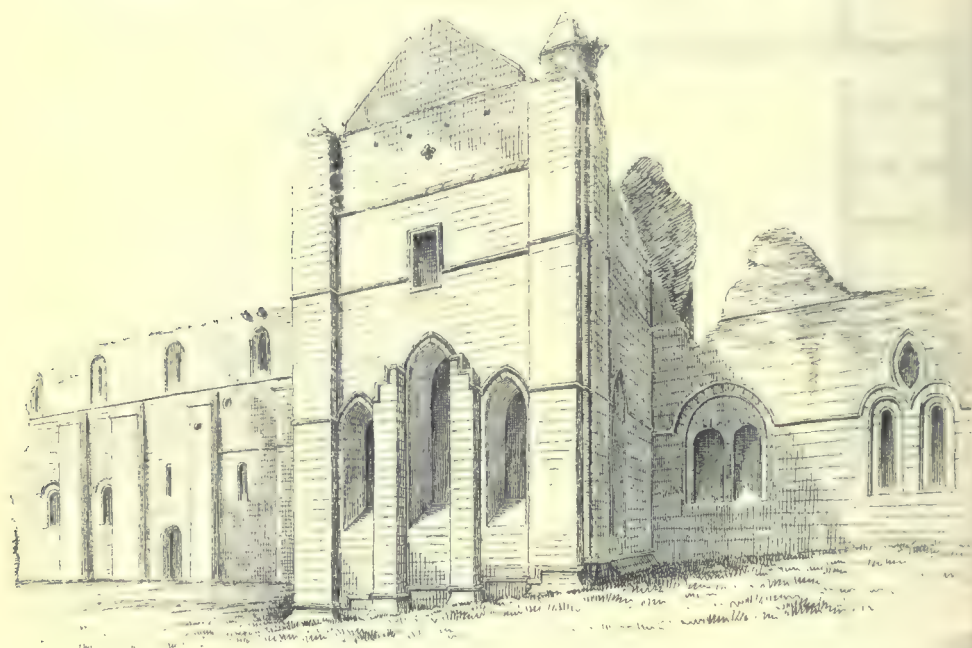
FIG. 411.—Dryburgh Abbey. East Side of Monastic Buildings.

The oldest portions of the structure are those forming the eastern range (Fig. 411), which, from their style of architecture, are evidently of transition date, or about the beginning of the thirteenth century. The sacristy is 28 feet long by 13 feet wide. It has a stone bench round the walls and three steps in the floor. There is a door from the transept and an outer semicircular-headed doorway of transition character from the cloister (Fig. 412.) Access is also obtained by a small door in the north side to a wheel-stair leading to the upper floors, and visible as a projecting turret at the south-east angle of the transept (see Fig. 412).

The east window of the sacristy is remarkable, having two round-headed windows, surmounted by a visica-formed aperture (see Fig. 411).

The east window is plain, and consists of two round-headed openings enclosed in a large semicircle (see Fig. 411). The above two apartments are on the level of the cloisters; but the floor of the chapter house, which is next in order, is several feet below the level of the cloister walk.

The chapter house is 48 feet in length by 23 feet in width, and retains its round barrel vault (Fig. 414), which is about 20 feet in height. It has three pointed windows in the east end (see Fig. 411) and two similar windows in the side walls, where the chapter house projects beyond the general line of the buildings. In the interior a round arched arcade runs along the east side, supported on single shafts, and there are traces of a similar arcade having run round the side walls. There is an entrance doorway in the south wall, which is probably not original, and the approach to it has been modernised. The east gable wall over the chapter

house still exists (see Fig. 411.) It has simple flat buttresses of a Norman type at the angles and between the windows, but the pointed arches indicate transition work.

The range of buildings above described still retains its eastern wall to the full height of two stories (see Fig. 411), the upper story being, doubtless, the dormitory. The wall is all built in a simple early style, with flat buttresses between the windows, and the latter are plain round-headed

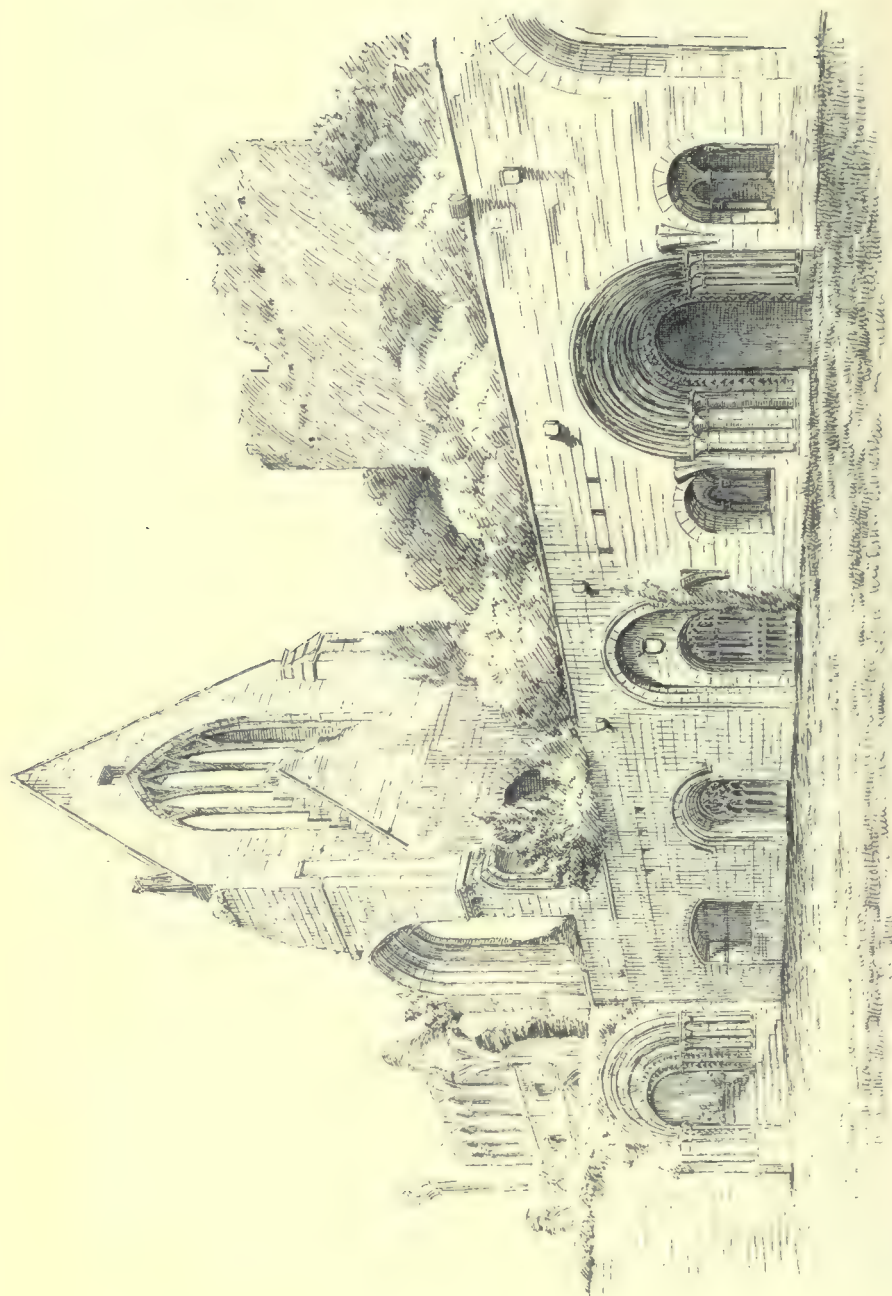
FIG. 412.—Dryburgh Abbey. Transept and East Side of Cloisters.

The apartment next the sacristy is 28 feet long by 11 feet wide. It has now been appropriated as a mausoleum, but may have originally been a parlour. There is an ambry in the south wall near the east end. The doorway is semicircular, and of Norman character (see Fig. 412).

The ordinary central doorway and side windows opening from the cloister (see Fig. 412) are, however, placed in their usual position on the level of the cloister walk. The door is thus some five feet above the floor, and if the doorway was used for access to the chapter house, it must have been provided with a stair down, of which there is now no trace. The

thirteenth century work, but, unfortunately, only a few detached portions remain. These include (see Fig. 412) the very picturesque gable of the south transept, with its large window filled with simple pointed tracery, rising in steps above the roof of the dormitory (Fig. 420). The arch through which the stair to the dormitory passed is visible in this wall. (See Fig. 420.)

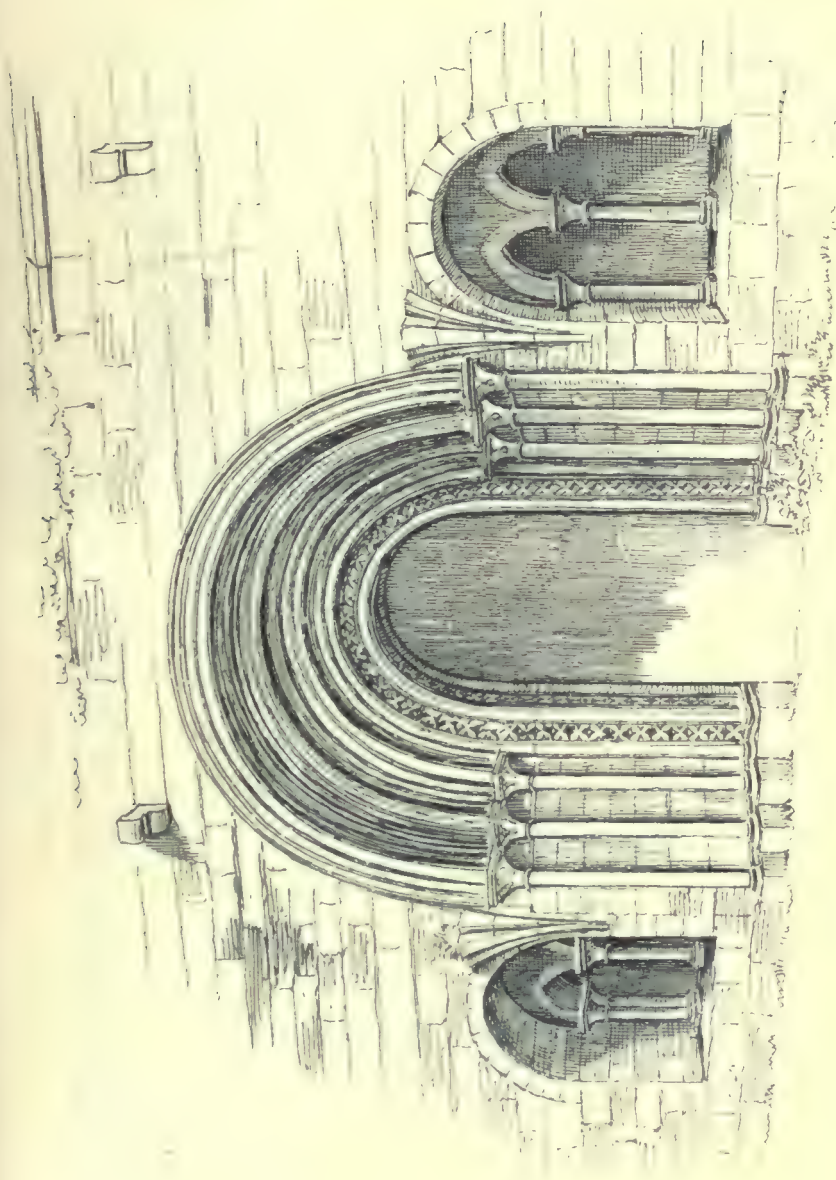
FIG. 413.—Dryburgh Abbey. Doorway of Chapter House.

The doorway (Fig. 413) is large and deeply recessed, having three shafts on the sloping ingoing, and plain mouldings above in the round arch, divided into several orders. The jambs and arch over them are enriched with a bold dog-tooth moulding. The outer arches of the windows on each side of the doorway are plain semicircles, filled in with two pointed lights, having a central shaft.

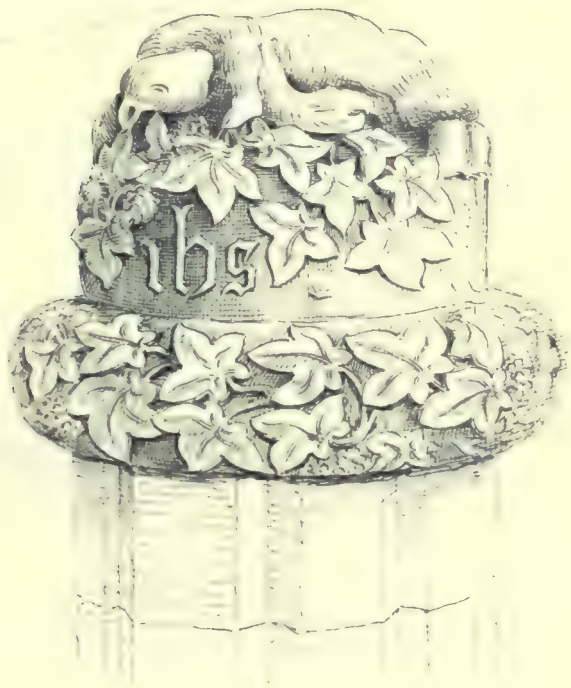
FIG. 415.—Dryburgh Abbey. Carved Figure in Chapter House.

Amongst the fragments of carved work preserved in the chapter house is that shown in Fig. 415. It represents the pascal lamb slain,

and is surrounded by a wreath of foliage, above which are the letters I H S. The vine leaves flowing from the lamb may represent the branches springing from the true vine.

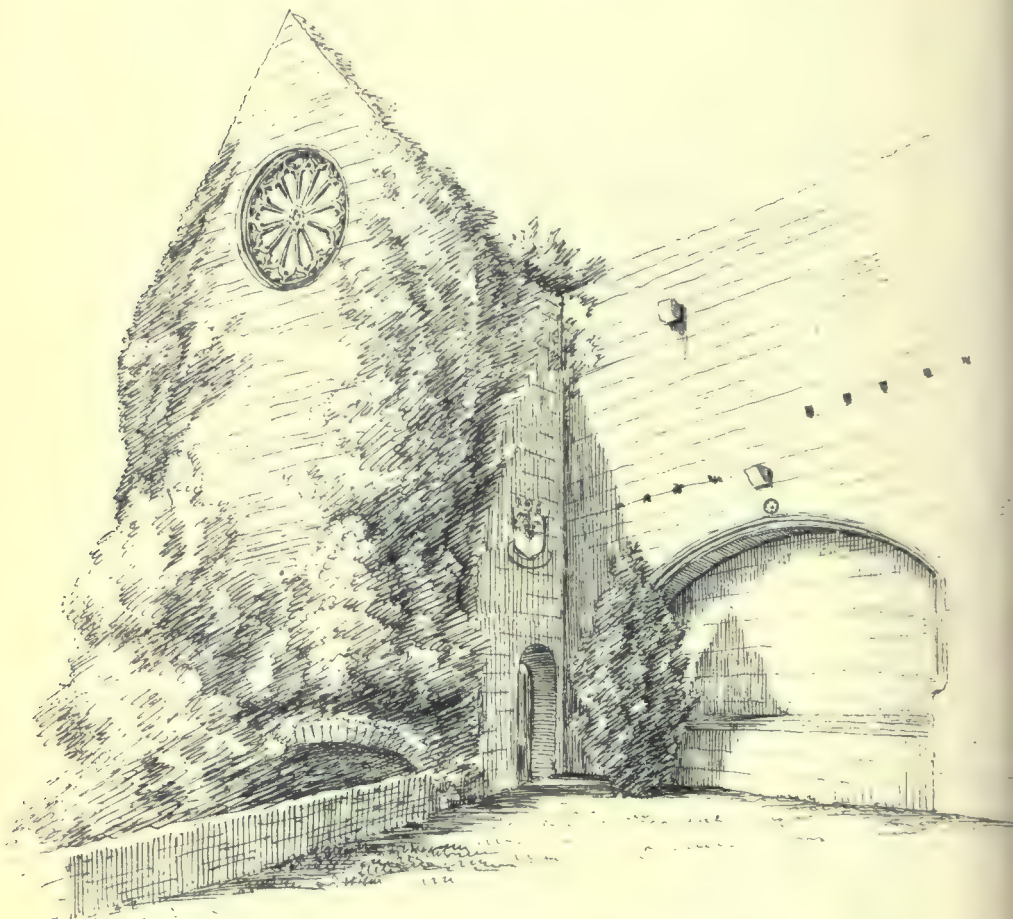
FIG. 416.—Dryburgh Abbey. South-West Angle of Cloisters.

which would thus be about 77 feet in length by 27 feet in width. The west wall is almost all that survives. It is ivy clad, and contains a picturesque circular window, with radiating tracery (Fig. 416). Adjoining

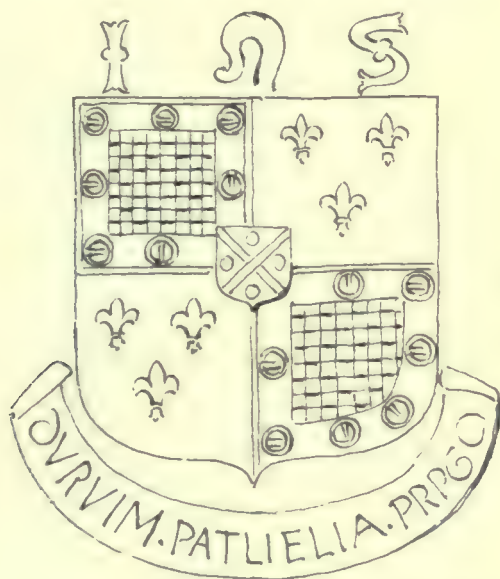
FIG. 417.—Dryburgh Abbey. Arms of John Stewart, 1355.

this wall in the south-west angle of the cloister there is an arched recess in the west wall, apparently intended for a tomb and monument; but it is empty. Over the doorway in this angle is a large shield (Fig. 417),

which contains the arms of John Stewart, who was commendator in 1555. On the shield are the initials "J. S.," with the crozier in the centre. He was brother of the Earl of Lennox, and uncle to Lord Darnley, who married Queen Mary. The arms are those of the Stewarts of Lennox.

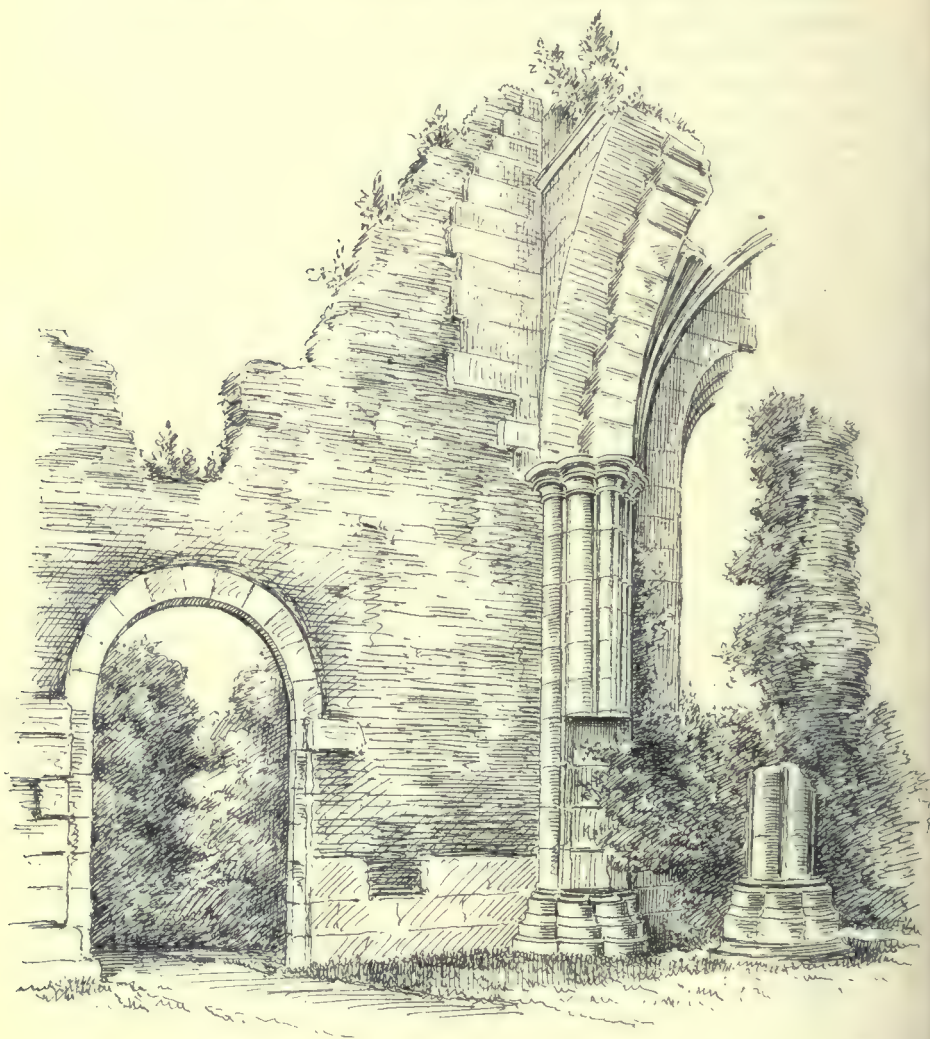
FIG. 418.—Dryburgh Abbey. West End of Nave—Interior.

The nave of the church is entered through this handsome doorway by ten steps up from the cloister. It presents a scene of terrible destruction. All the piers of the nave are demolished, and only slight traces of the north wall remain; of the south wall, more is preserved. The west end wall (Fig. 418), however, has to some extent escaped destruction, and shows by the responds attached to it the form of the nave piers, with their caps and bases. The position of the piers along the nave is now roughly indicated by a collection of fragments arranged, as nearly as possible, in the original position and form. The mouldings indicate a late date, and were, doubtless, restorations; but the responds, which were not so liable to destruction, are of first pointed date. The responds which form part of the west wall show that there was a central nave 28 feet wide and side aisles, each about 13 feet 6 inches wide, making a total width of 55 feet. There have been side chapels in the nave, apparently divided by walls, some portions of which remain, with ambries in the chapels.

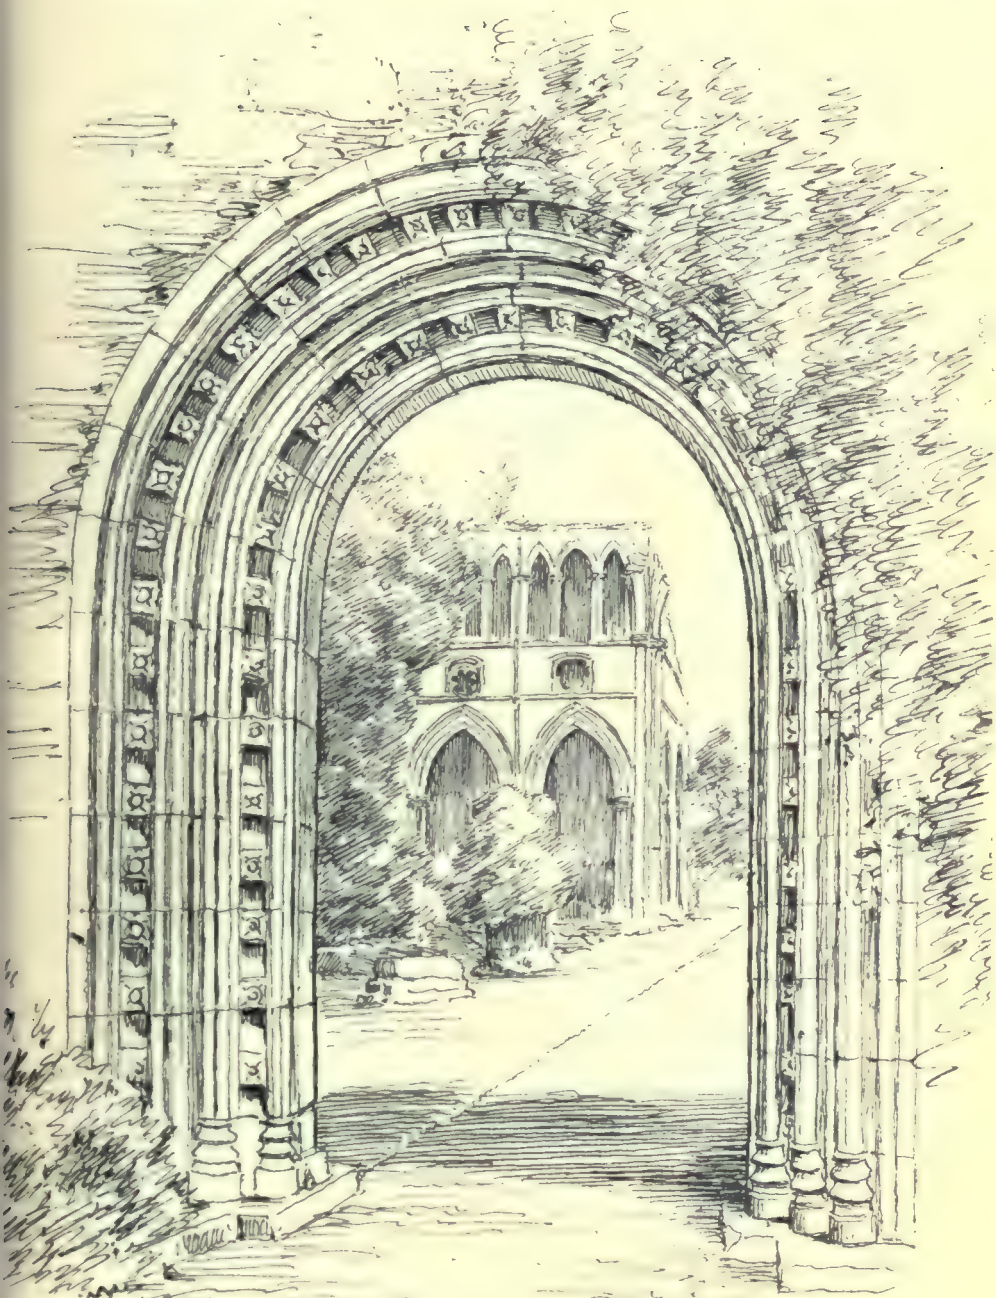
FIG. 419.—Dryburgh Abbey. Western Doorway.

The western doorway (Fig. 419) has a round arched head, but its details show that it is of late design. This part of the edifice has apparently been restored in the fifteenth century, after the destruction of the abbey by Richard II. in the end of the fourteenth century.

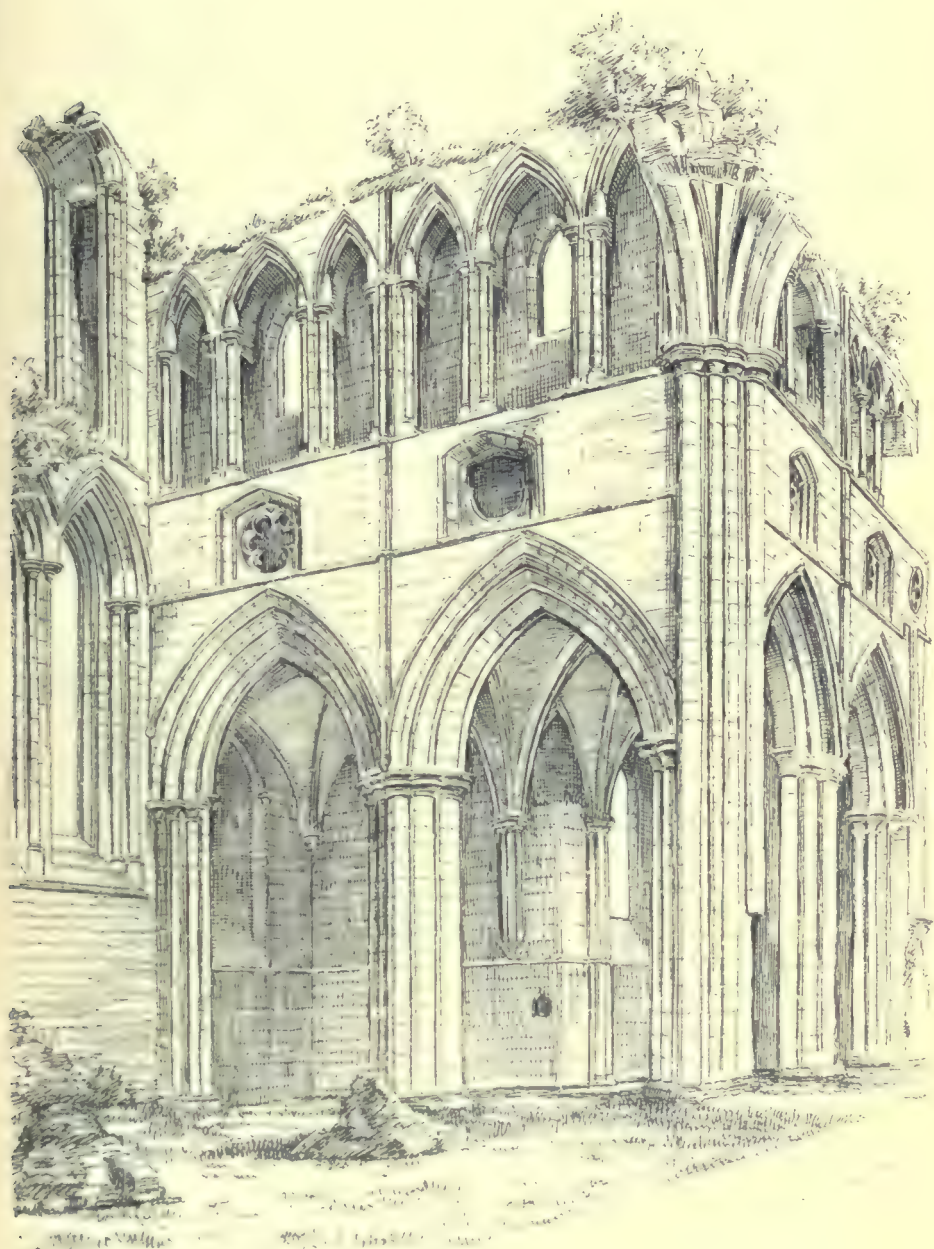
FIG. 421.—Dryburgh Abbey. North Transept and Choir.

To the east of the transept is a choir of two bays, with aisles, beyond which is an aisleless presbytery, 42 feet long by 24 feet wide, now almost reduced to foundations. The buttresses and base course are traceable, and a doorway in the north-east angle, which probably led to a small staircase. The portion of the structure still preserved to the north is a part of the north transept wall, with the eastern aisle of the transept and the two north bays of the choir (Fig. 421).

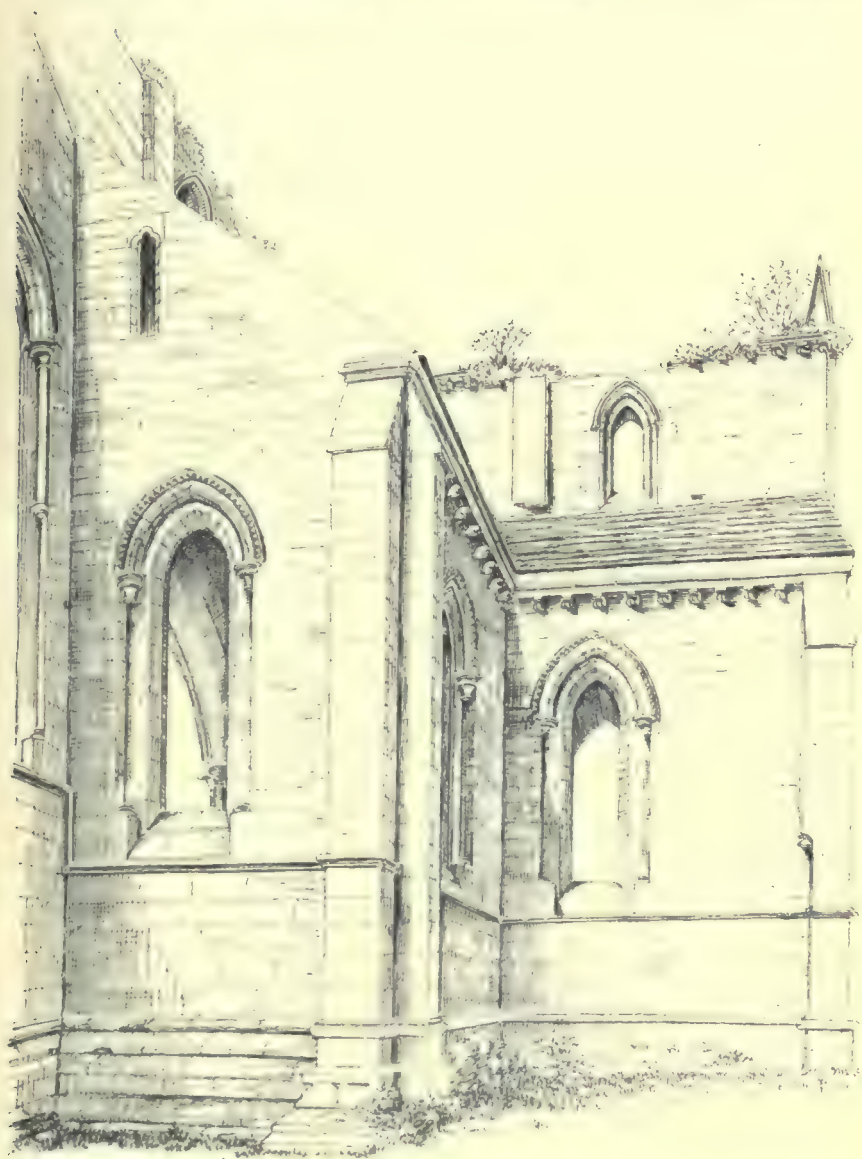
FIG. 422. Dryburgh Abbey. Choir-Aisle and North Transept.

These portions are of very beautiful design, both internally and externally. The exterior (Fig. 422) is of very simple, but elegant, first pointed work, while the interior shows symptoms of somewhat more advanced design. The angle pier of the crossing and the piers of the choir consist of round shafts with fillets, divided by square angles. These are surmounted by moulded caps, with round abacus and first pointed mouldings. From these spring the pier arches, composed of three orders of plain splays, with hood moulding. Over the main arches is a low triforium marked by string courses above and below. It has flat arched openings filled in with circles having six cusps.

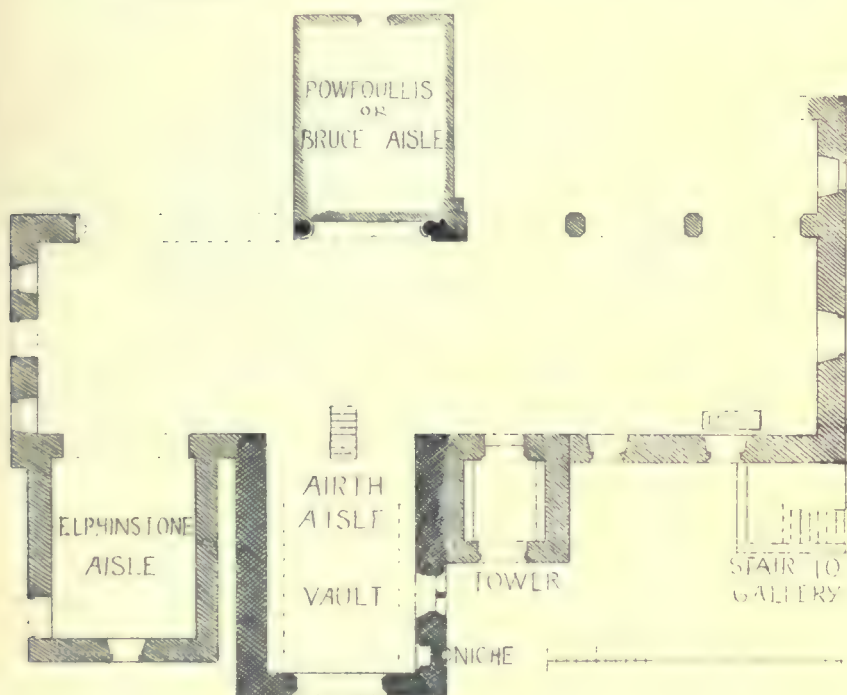
FIG. 423.—Airth Church. Plan.

This ruined church adjoins the old Castle of Airth, which lies half a mile from the Forth and eight miles south-east of Stirling. The church is in part a building of considerable antiquity, dating from the transition period about the end of the twelfth or the beginning of the thirteenth century, but it has undergone many alterations, and only a small part of the early structure remains. The building as it now stands (Fig. 423) consists of a

nave and chancel, having a south wing or aisle, containing the Airth vault, and forming a transept, with a tower at the re-entering angle of the Airth aisle, and with indications of an aisle on the north side of the choir. There are also two burial vaults attached to the building, one on the north side and the other at the south-west angle, called respectively the Bruce and

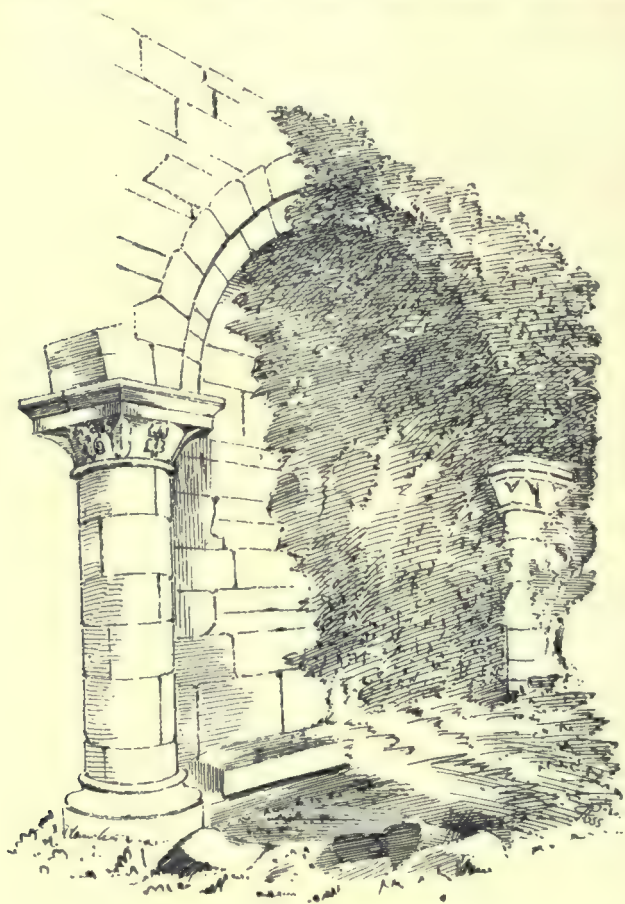
FIG. 424.—Airth Church. North Arcade.

Elphinstone aisles. The internal length of the church is 79 feet 3 inches by about 19 feet 9 inches in breadth. The most ancient part of the church (Fig. 424) is on the north side of the nave, and consists of a bay of what has been a nave arcade, opening into a north aisle. One pillar and respond (tinted black on the Plan), with the connecting round arch, still

stand. The original arcade probably consisted of three bays extending to near the west gable, where there are indications, at the ground level, of what appears to have been the western respond. Whether there was originally a south arcade or not cannot now be determined, as this part has been entirely rebuilt, and all traces of the north and south aisles of the nave, if there was a south aisle, have perished. The existing north

bay is 11 feet 3 inches wide, and the pillar, which is circular, is about 17 inches in diameter. It has a capital, carved with simple foliage (Fig. 425), and has a square abacus. The arch has a double set of plain arch stones, with plain soffit.

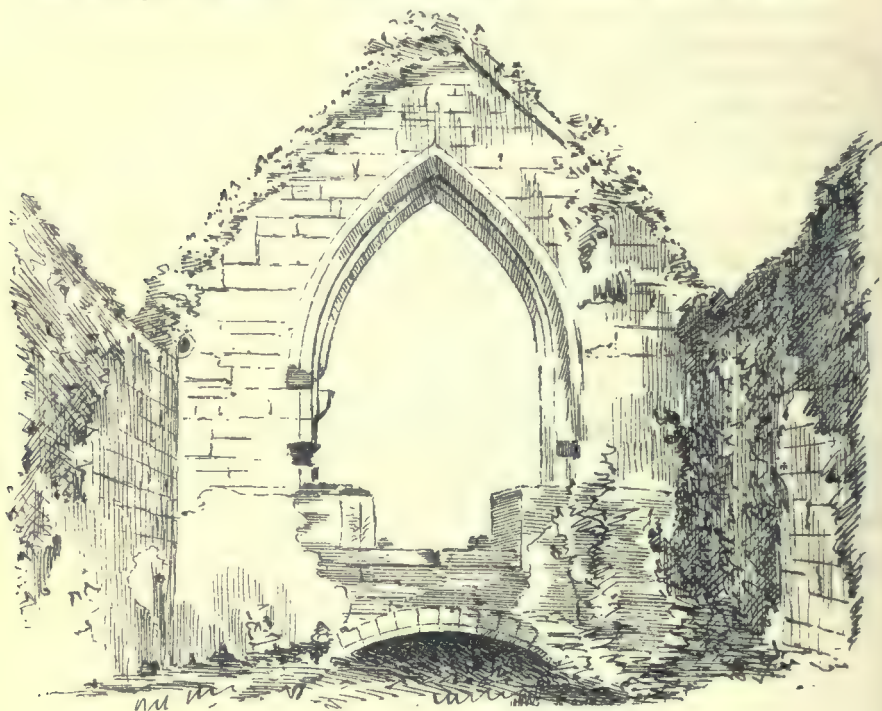
FIG. 426.—Airth Church. The Airth Aisle, looking South.

Judging from the few details left, the Airth aisle is a structure of the fifteenth century. It measures about 24 feet 3 inches long by 13 feet 3 inches wide, and has contained a large traceried south window, which is now destroyed, and brought to the condition shown in Fig. 426. The external hood moulding of the window remains with nicely carved terminations (Fig. 427). Beneath this window is seen the top of an arched tomb, in which probably the recumbent effigy (Fig. 428) once lay. There is a small square-headed window in the east wall, divided by a mullion; but, as appears from its mouldings, it is an insertion of perhaps the seventeenth century. Adjoining this is the usual ambry. Beneath this aisle is the burial vault (indicated by dotted lines on the Plan), which is reached by the stair shown. On the outside of the east wall there is a niche for a statue (Fig. 429). It has the usual canopy and bracket so frequent on the churches of this late period. The bracket (Fig. 430) contains the Bruce arms—viz., the chief and saltier; the chief being

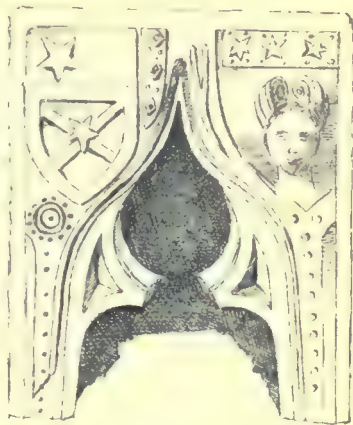
FIG. 431.—Stone in Airth Castle.

In Airth Castle is preserved the stone shown in Fig. 431. It appears to have been taken from the church and to have formed a part of a piscina or ambry. The fragment measures about 2 feet high, with an opening about 12½ inches wide. It doubtless belonged to the Airth aisle.

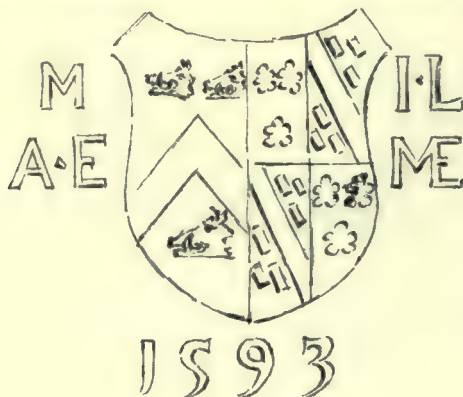
FIG. 432.—Airth Church. Stone in South Gable of Elphinstone Aisle.

The Elphinstone aisle, which is separated from the nave by a semi-circular arch, presents no architectural features of note; but on the exterior of the gable towards the south there is a well-preserved stone (Fig. 432), with shield bearing the Elphinstone arms, parted per pale with those of Livingstone and Calendar quarterly, with the motto "Cavis Cavis" (Caus Caus), the date 1593, and at either side the letters M A ♦ E and I ♦ L ME, the initials of Alexander, fourth Lord Elphinstone, and his wife Jane, eldest daughter of William, sixth Lord Livingstone.

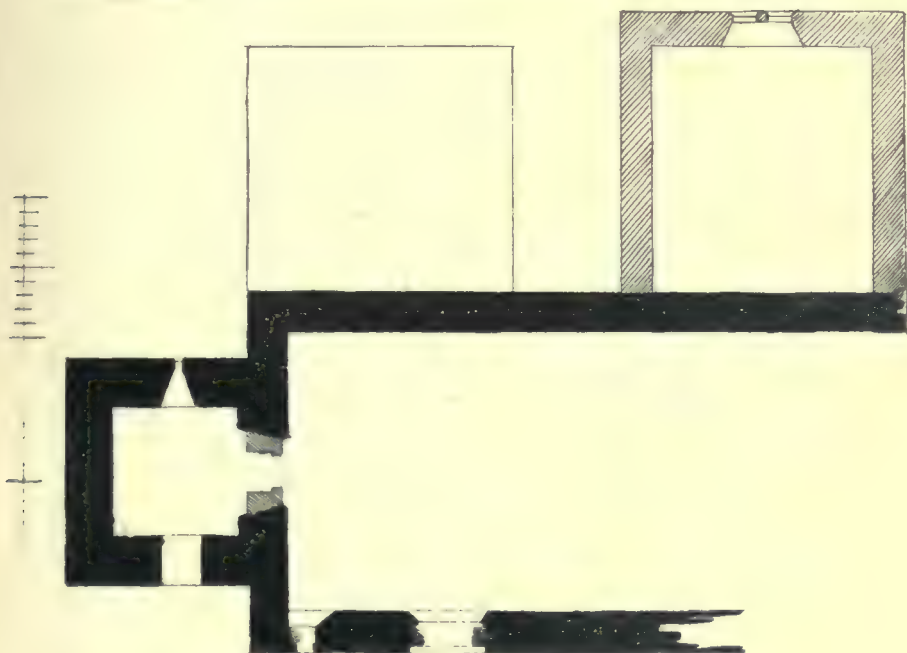
FIG. 433.—Lasswade Church. Plan.

The old church (Fig. 433) consisted of a single oblong chamber 20 feet in width, with a tower 16 feet square at the west end. The aisles, or

mausoleums, above referred to, are projected from the north side. The westmost is roofed with stone slabs, and has a picturesque appearance.

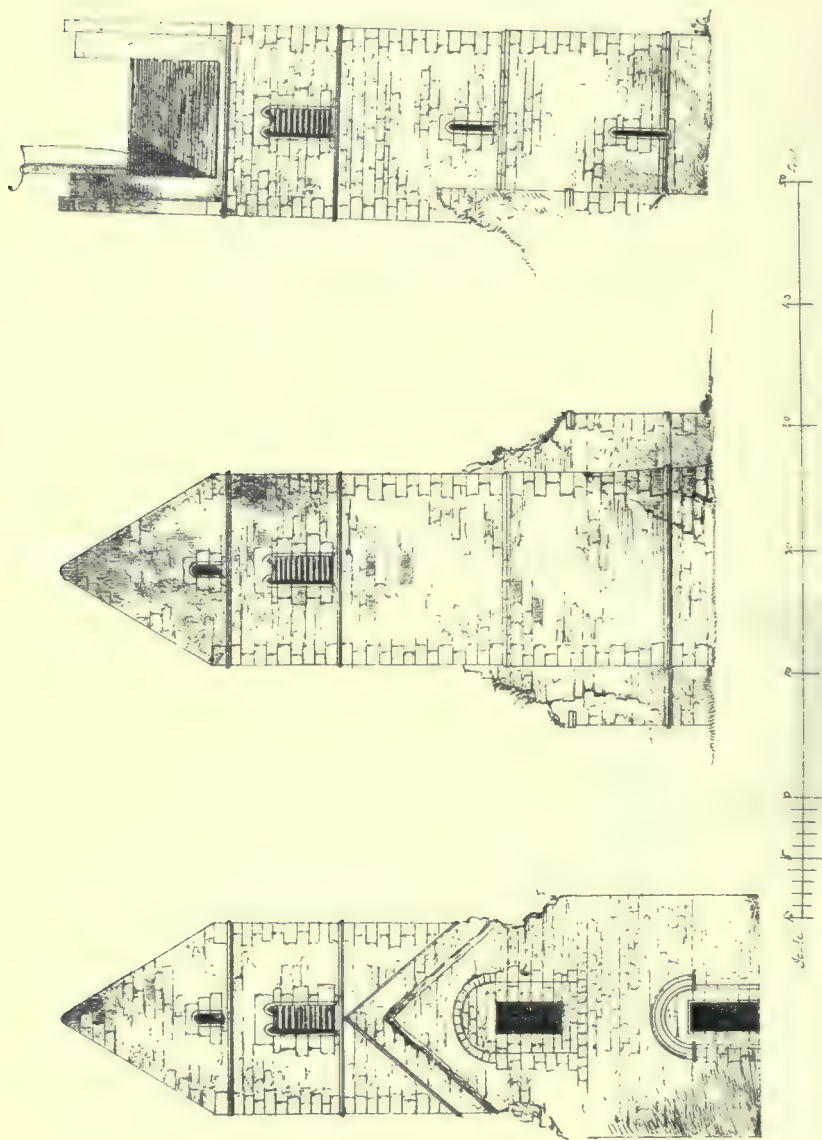
FIG. 434.—Lasswade Church. East, West, and North Elevations.

The tower (Fig. 434) was three stories in height, besides the gables of the saddle roof which crowned it. The entrance to the tower was from the inside of the church by a round-headed doorway (see East Elevation), with simple impost and plain arch with hood moulding. Above this was a large round-arched opening into the roof of the church. The two lower stories had narrow pointed windows. The top story had

double-pointed lights, with central mullion in each face. This story had an enriched cornice, above which rose the east and west gables, each with a small round-headed window. A door had been knocked into the tower on the south side (Fig. 435), which, doubtless, helped to weaken it.
